YOUR Guide

LIME KILN BAY WETLAND

Lime Kiln Bay Wetland

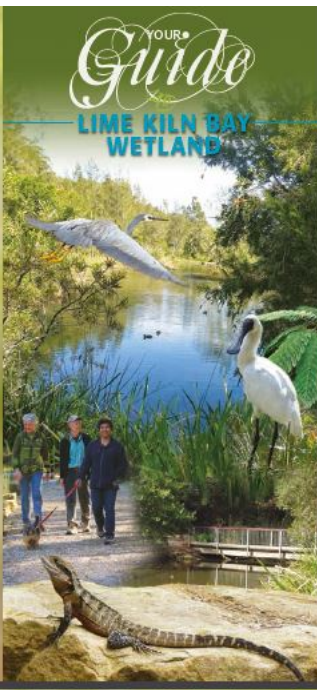
Catchment

Any substance entering street drains from within the marked catchment outline will eventually find its way into the wetland. This catchment covers a sizeable area of about 2 square kilometres (200 hectares) from Forest Road to Ocean Street, Illawarra rail line and across to Mulga Road and Lloyd Street. This is a dense urban area containing about 4000 homes and up to 10,000 residents. It also includes the shopping centre at Mortdale and other commercial properties.

Because much of the catchment is covered with hard surfaces, e.g., houses, roads, concrete driveways and footpaths, water runs off rather than soaking into the ground. In doing so, it flows quickly carrying pollutants with it.

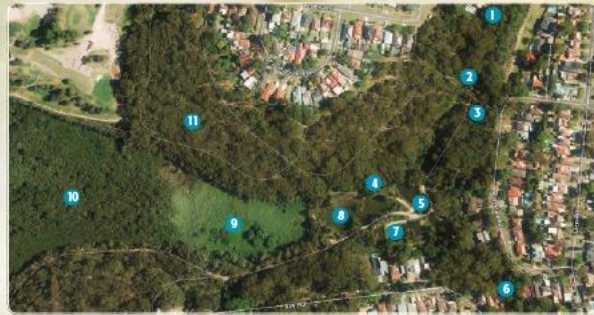
Lime Kiln Bay Wetland is located in Oatley and is bordered by Oatley Park, Bay Road, Riley Street, Waterfall Road and Oatley Heights Park. It is a constructed pond system built by Hurstville City Council in 1999/2000 at a cost of \$12 million and was opened in September 2001.

The system was designed to firstly stop gross pollutants such as plastic, paper and organic matter, then settle out the sediment and remove nutrients. Thus, preventing pollution from flowing into Lime Kiln Bay and eventually the Georges River.

1. Dairy Creek

Typical of many urban areas, stormwater runoff enters the natural creek system via road drainage, backyards, road drains and pipe systems, potentially introducing weeds, nutrients and other pollutants.

2. Sewer Submain

The North Georges River Submain (NGRS) sewer viaduct crosses Dairy Creek incorporating an emergency relief structure (ERS) to release excess wet weather flows. It also acts as part of the Lime Kiln Bay Great Track.

3. Gross Pollutant Trap

To remove large pieces of debris and rubbish washed down the creek from surrounding urban catchment, this trap has been constructed with easy access to facilitate regular clearing.

4. Bypass Flow

Although almost 100% of the creek flow is directed through the wetland, during times of flood the excess flow bypasses the wetland to avoid damaging reeds and other infrastructure.

5. Sediment Pond

Downstream from the Gross Pollutant Trap, this pond has been created to allow sediment particles to settle out prior to entering the wetland.

6. Waterfall Creek

This creek is fed by road drains and a pipe system. It enters the wetland at the southern end of the sediment pond.

7. Easton Ridge Wetland

A more recent addition to the wetland, this now provides a longer flow path through the pond system.

8. Constructed Wetland

This man-made wetland completed in 2000 has a catchment in sloping urban off-filling urban lots and other pollutants, as well as providing native fauna habitat.

9. Natural Reeds

The *Phragmites* reeds provide a final shallow wetland which slows stormwater flows and catches pollutants before entering the mangroves and waters of Lime Kiln Bay.

10. Mangrove Community

Naturally occurring native mangroves line the bay and provide many valuable ecological functions.
